Manhole Inspection Summary

Manhole # S03UU1009MH

Insp Date: **8/16/06 12:00 AM**

Location Address: **5801 NARCISSUS AVE**

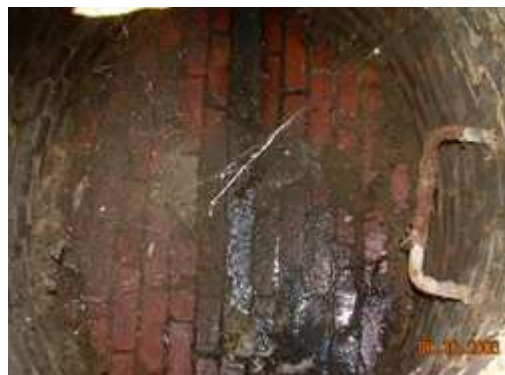
Top View

Corbel and Barrel infiltration. Corroded step. Bench debris.

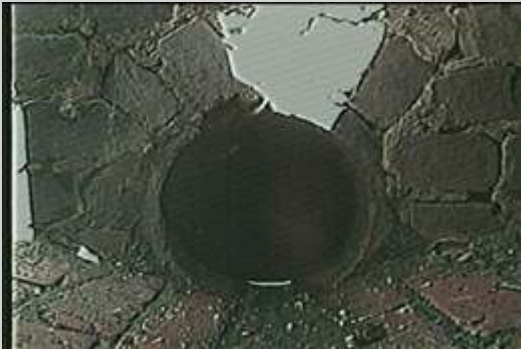
8 in. Circular Gravity Sewer Pipe Out @ 12 O'Clock

Comments **The O12 pipe picture shows Barrel deterioration.**

Infiltration: **Evidence** Pipe Seal Cond: **Broken**

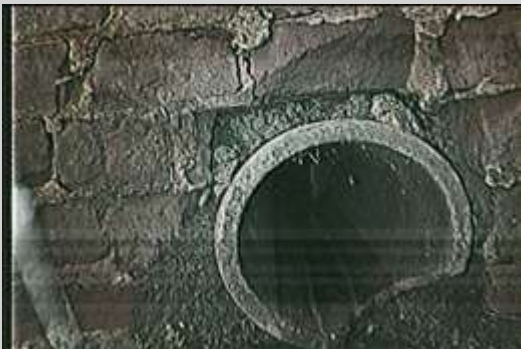
6 in. Circular Gravity Sewer Pipe In @ 5 O'Clock

Infiltration: **Evidence** Pipe Seal Cond: **Roots**
